TASK NO. 2 - SOUTH PLANTS DRAFT FINAL SOURCE REPORT SITE 1-10

October 1986 Contract No. DAAK11-D-0017

FOR SITE 1-10, SOUTH TANK FARM

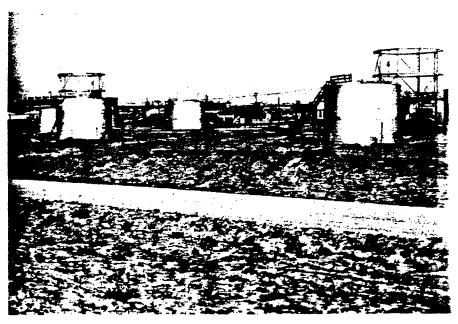
FIGURE 1.1-3 SITE 1-10 SOUTH TANK FARM Looking Northeast at Tank in West Part of Site

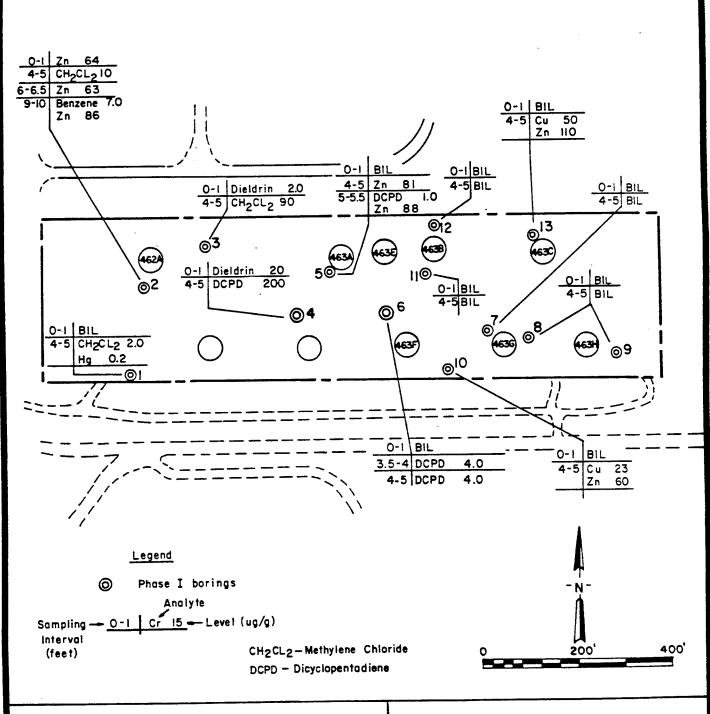
FIGURE 3.1-1

Metals detected within or above their respective indicator ranges in samples from Site 1-10 were copper, chromium, lead, mercury, and zinc. The amounts detected appear to be fairly uniformly distributed both laterally and vertically throughout the site. Mercury at 0.2 parts per million (ppm) was detected in one sample (the 4-5 ft interval of Boring 1). Copper and zinc within or above their indicator ranges were detected in samples from Borings 2, 5, 10, and 13. The distribution of the constituents within or above their indicator ranges detected at Site 1-10 in the Phase I program is presented in Figure 3.1-1.

Analytes Detected Above Indicator Level at Site 1-10
